TIRE AGING:
A Summary of NHTSA's Work

U.S. Department of Transportation
National Highway Traffic Safety Administration

March 2014

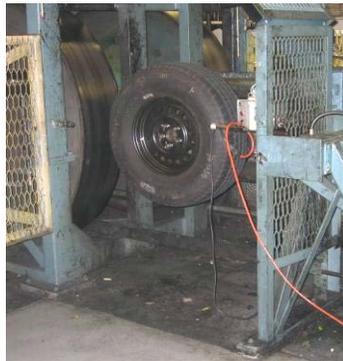
six tire models, a total of 172 in-service tires and nine full-size spare tires of varied ages and mileages were compared to 82 new, unused tires of the same makes and models to determine overall rates of degradation in whole-tire performance and component material properties. Both the new and Phoenix-retrieved tires were subjected to stepped-up speed (SUS)²² and stepped-up load (SUL)²³ tests until tire failure²⁴, both of which were performed on a 1.7-m (67-inch) diameter indoor laboratory roadwheel (See Figure 1).

Figure 1: Roadwheel test

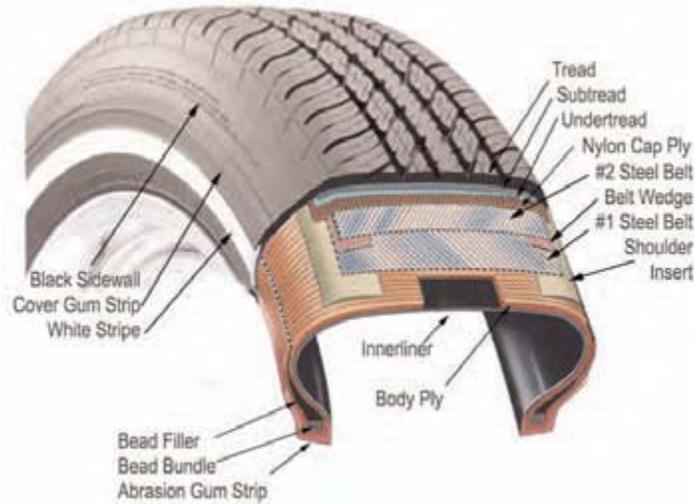
Figure 2: Components of a radial tire³¹

Approximately 70 percent of the failures³² for passenger car tires took place in the critical belt edge and shoulder region of the tire (see Figure 2 for tire components). The light truck tires failures were predominantly separations between components in the innerliner and sidewall region of the tire, including two tires that separated in the oven during aging. Inspection of the failures indicated that the separations were likely initiated by a buildup of air pressure between the components. Some of the failure modes observed were the following: belt edge separation, separation between belts, loss of tread and belt, tread element tear/chunk out, innerliner detachment, sidewall split and rupture, white sidewall separation, tread and belt separation, black sidewall separation. Appendix B contains pictures of some of the failure modes observed and Appendix E includes a list of failure modes for all tires after five weeks of oven aging.

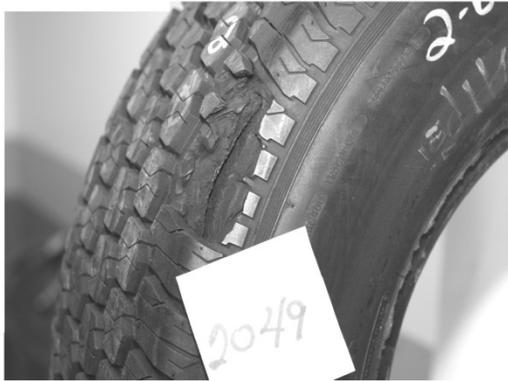
Figure B1: Belt edge separation

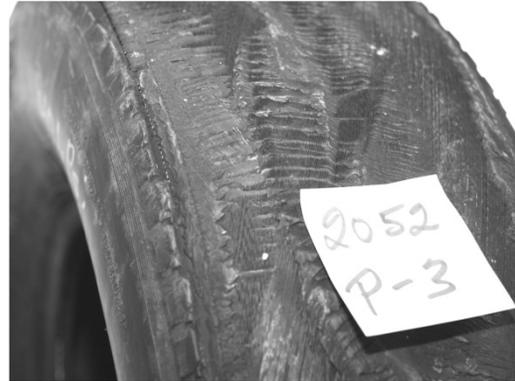
Figure B2: Loss of tread and belt

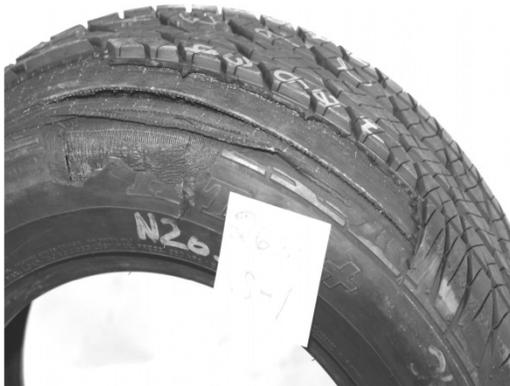
Figure B3: Tread and belt separation

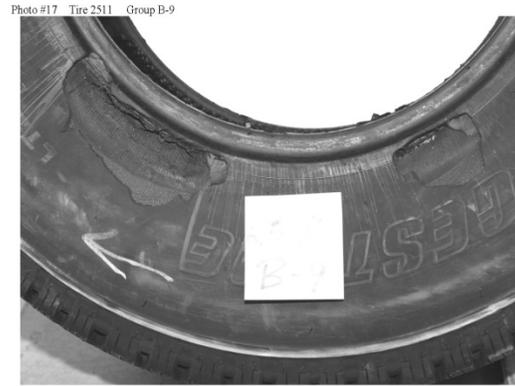
Figure B4: Black sidewall separation

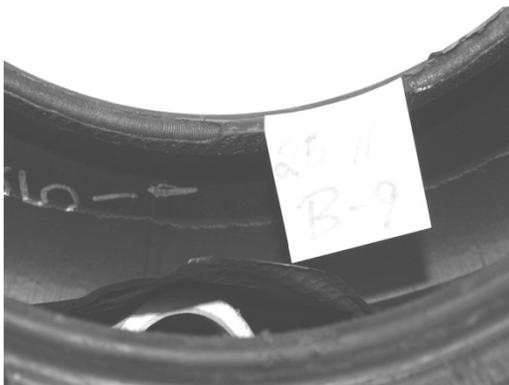
Figure B5: Innerliner detachment

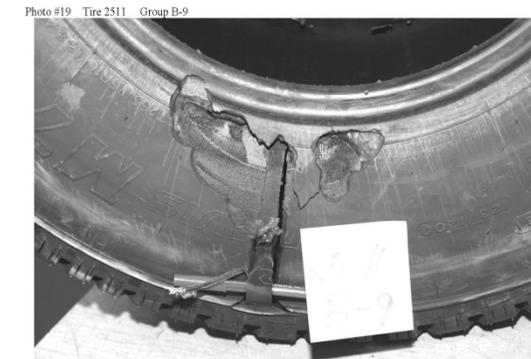
Figure B6: Sidewall split and rupture

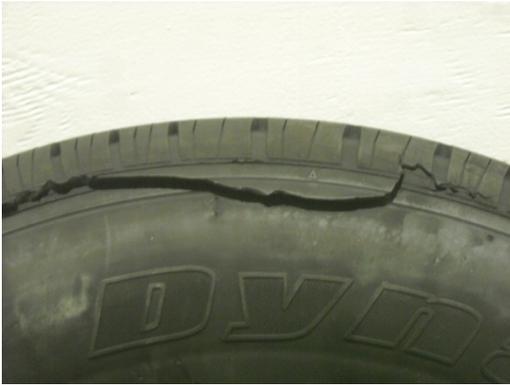
Figure C1: Tread separation at shoulder

The most frequently occurring failure was cracking in the shoulder (55.6 percent), other failure modes observed were: cracking in tread groove (22.2 percent), cracking in base of tread at shoulder (18.5 percent), tread separation at shoulder (18.5 percent). Smaller percentages of tread shoulder blister, tread chunking, cracking in sidewall, sidewall delamination, sidewall bubbles, sidewall deformation at splice. See Appendix C for some pictures of the failure modes observed and Appendix F for a list of the failure modes for all the tires tested.

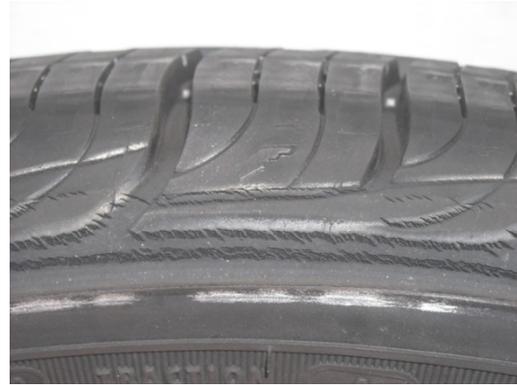
Figure C2: Cracking in shoulder

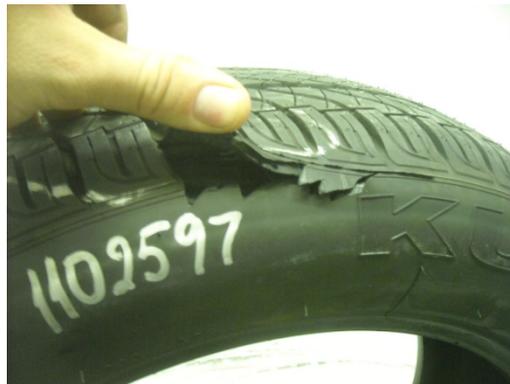
Figure C3: Tread shoulder cracking out of oven

After five weeks in the oven, the tires were removed and inspected for signs of oxidation damage. All three tires from one model exhibited tread shoulder cracks and exposed belt edges after oven-aging. One of these tires experienced total air loss in the oven.

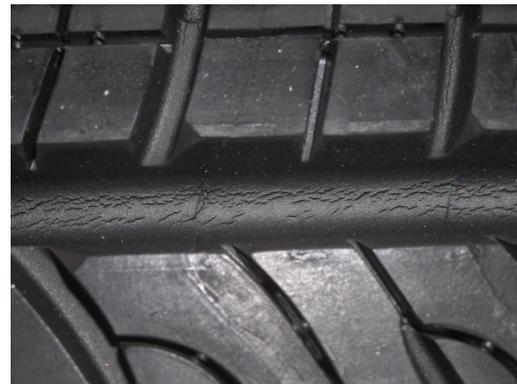
Figure C4: Cracking in tread groove

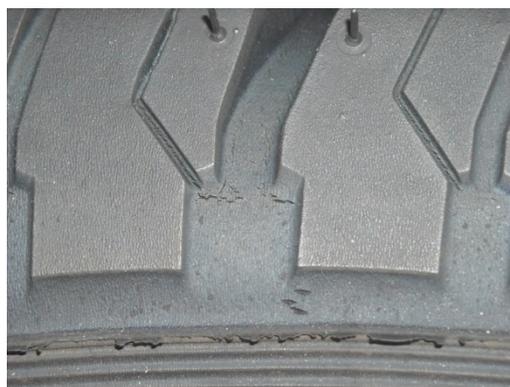
Figure C5: Cracking at base of tread shoulder

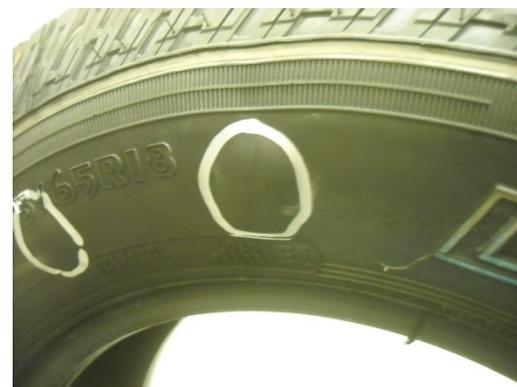
Figure C6: Sidewall bubbles
